**YMN**  
**TANKER**

# HSSEQ BULLETIN

Q1 2026 / ISSUE 25

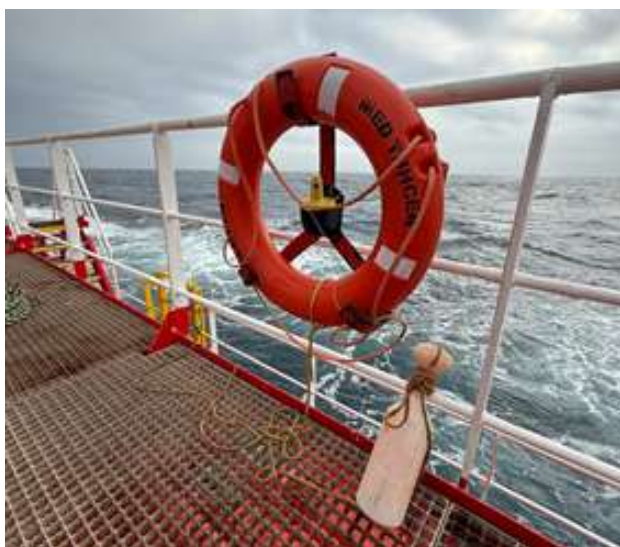
## BAD PRACTICE

At the pilot access point, a lifebuoy equipped with a self-igniting light and a separate heaving line are available. However, the heaving line is attached directly to the lifebuoy instead of being stored separately.

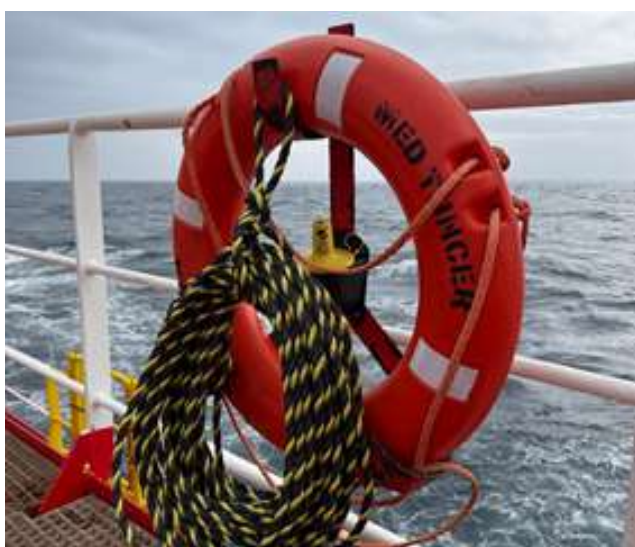
## GOOD PRACTICE

At the pilot access point, a lifebuoy equipped with a self-igniting light and a separate heaving line are readily available. The heaving line is stored separately from the lifebuoy in a ready-to-use condition, and NOT attached to the lifebuoy.

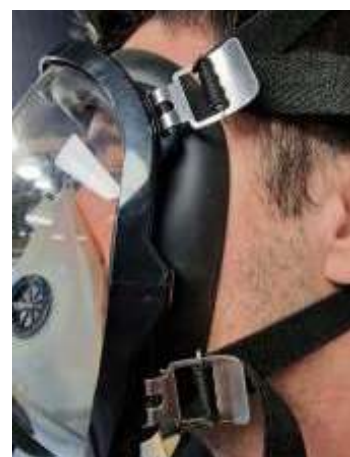
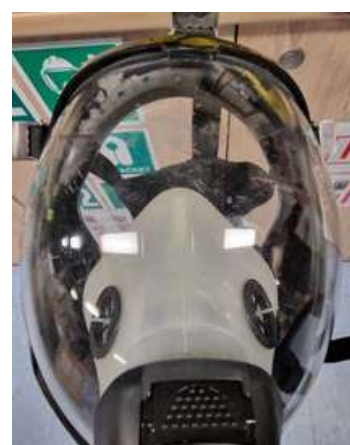
During a scheduled fire drill, it was observed that a member of "Fire Team 1" failed to properly don their BA (Breathing Apparatus) mask. Following this observation, the firefighter adjusted the internal nose and mouth cup before proceeding with the intervention. \* Additionally, due to the rush of putting on firefighting gear quickly, the mask's tensioning straps were pulled with uncontrolled force, causing the buckles to snap suddenly. This rendered the mask unusable; it was subsequently replaced with a functional unit to continue the drill.

- Unintentional misuse (Incorrect donning technique).
- Lack of attention and excessive haste.
- Lack of training (Lack of familiarity with equipment limitations).

- The proper donning of a BA mask is critical during firefighting or enclosed space rescue operations;
- Any failure increases the risk of the rescuer becoming a casualty. Therefore, mask straps must be
- Tightened evenly and the inner nose cup must be perfectly centered on the face to ensure safety.
- While speed is essential during drills, rushed actions increase the margin of error and the risk of
- Equipment damage. To prevent such incidents, practical training should be intensified to improve the
- Muscle memory and technical proficiency of personnel during the donning process

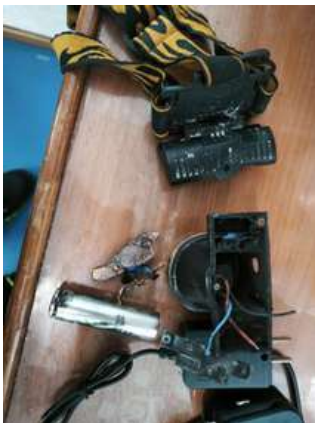
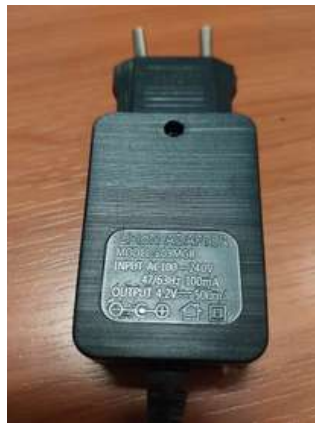
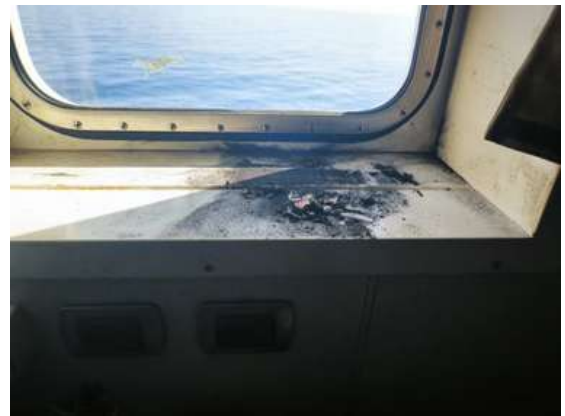
Shortly after a crew plugged the headlamp which had been assigned for his use into a charger in his cabin, the integrated battery of a headlamp exploded.

- Improper operation of device
- Incorrect / inadequate tool / equipment
- Lack of situational awareness/risk perception/risk awareness

- The investigation revealed that there were two types of headlamps on board a vessel, one has 0,5 amper batteries and the other type with 2,5 amper batteries, and it was determined that the battery was exposed to a current over the capacity due to usage of an incorrect charger.
- The fact that the crew was in the cabin at the time of the incident and immediately unplugged the device and notified to Chief Officer, prevented a potential fire.
- If the crew had been in his cabin at the time of incident, he could have been injured as well.
- In the light of above three assessments, planned to install a battery charge station in order to minimize potential faults and the risks of injury and fire arise from.
